CASE STUDY

► Aston, Pennsylvania Relocation Project

A small, complex stream relocation project in the natural gas & petroleum industry.

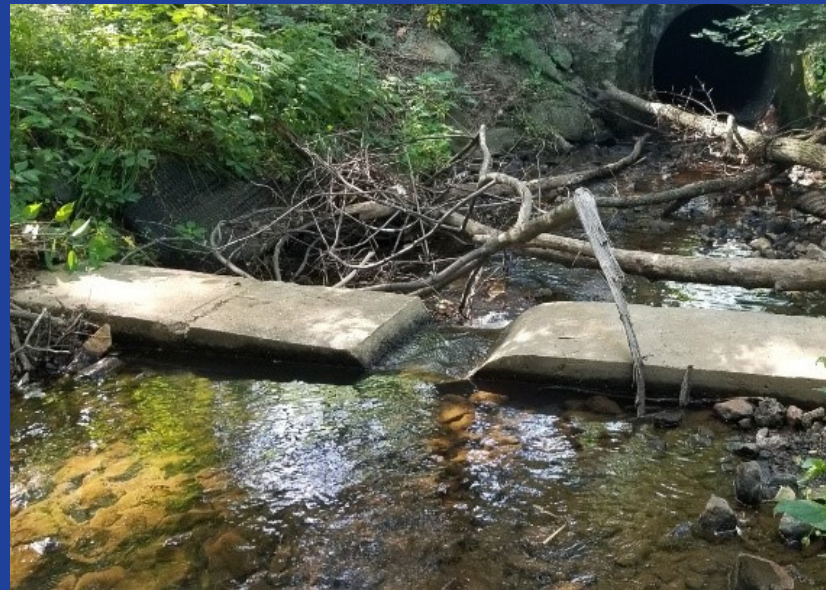
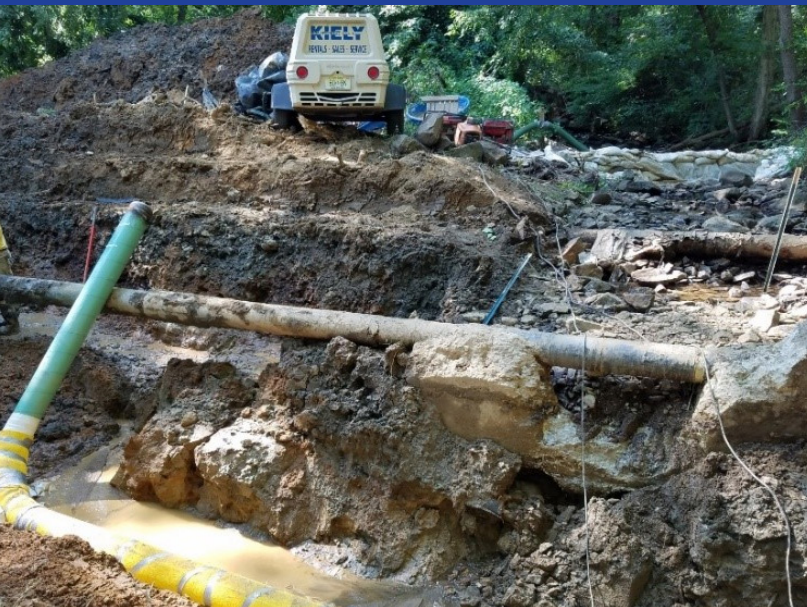
To execute the project in adherence to the defined plans, field team members installed timber mats through a residential yard to gain access to the stream. The crew also installed BMP's, consisting of silt fence and dewatering devices including a pump filter bag, straw bales, etc. A stream pump around was then conducted to begin excavation.

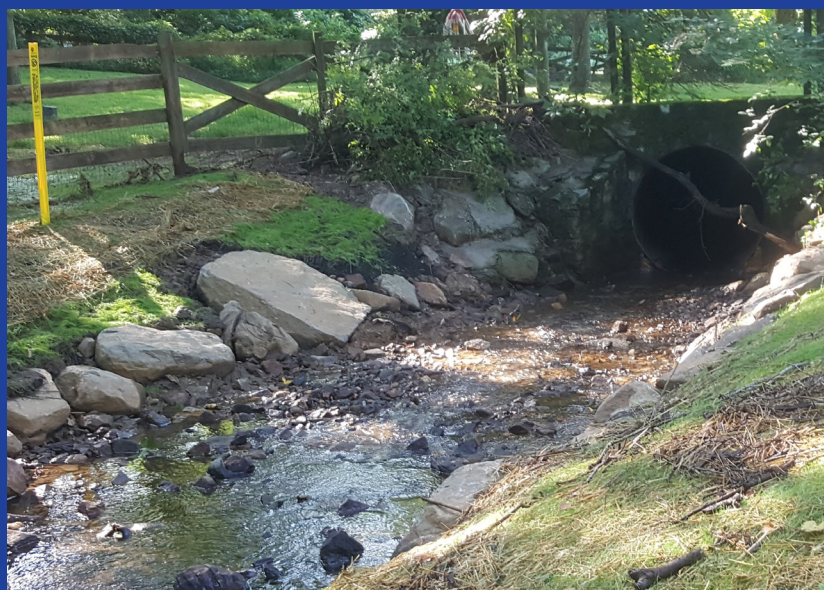
The stream crossing and lowering included the installation of a 120', ARO coated, 8.625" diameter steel pipe. Kiely's team excavated the stream to allow a 48" minimum cover of the final install. Following fabrication, Kiely installed, radiographed and pressure tested the pipeline.

As the tie-in dates approached, Kiely provided the purge plan and field execution of the 6-mile pipeline purge. The existing line was then cut and the new pipe was tied in. Upon project completion, Kiely restored the stream and banks to its' pre-existing conditions. The project team performed all phases of the project from concept to completion, resulting in seamless integration between design, permitting and construction teams for economy, efficiency, and success.
